## Department of Health

November 30, 2018

**PUBLIC WATER SYSTEM**  
Watkins Glen Village  
Sanitary Survey - 2018

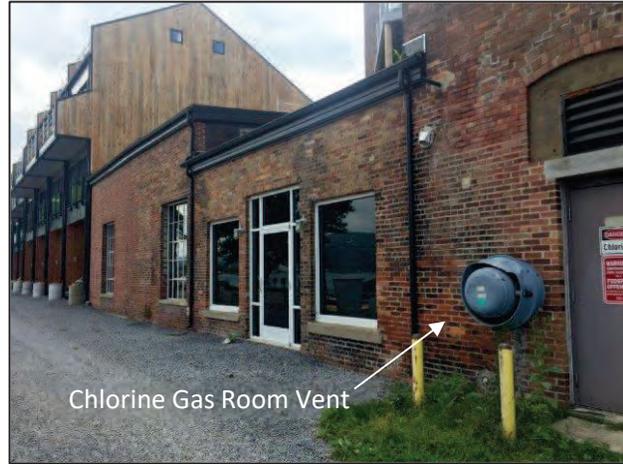
1. The Village is in violation of Title 10 of the New York State Code of Rules and Regulations, Subpart 5-1, Public Drinking Water Systems (hereafter Subpart 5-1) Subpart 5-1.71 (b) for failure to exercise due care and diligence in the operation of a water treatment plant or distribution system. There is no provision for an alarm to notify the operator of a chlorine gas leak at a remote (not typically staffed) location. Potential release of chlorine gas is an immediate health and safety concern. In addition to the failure to alarm the operator, no provision is made to chemically neutralize a leak as required by Subpart 5-1 Appendix A, Recommended Standards for Water Works (RSWW). Chlorine gas is a toxic substance and the recent development of apartments in the adjoining building makes this a significant risk to neighboring residents.

Figure 1: Raw Water Chlorine Gas Room & Apartments

1. The Village must explore alternative forms of treatment at the intake. As noted previously the location of the chlorine gas adjacent to apartment buildings is a safety and health hazard. Should there be a release, the vent for the room will discharge gas into the driveway for the apartments, and into the pathway of anyone attempting to access the room. Using a different chemical for zebra mussel control may also improve disinfection by-product levels in the distribution system.

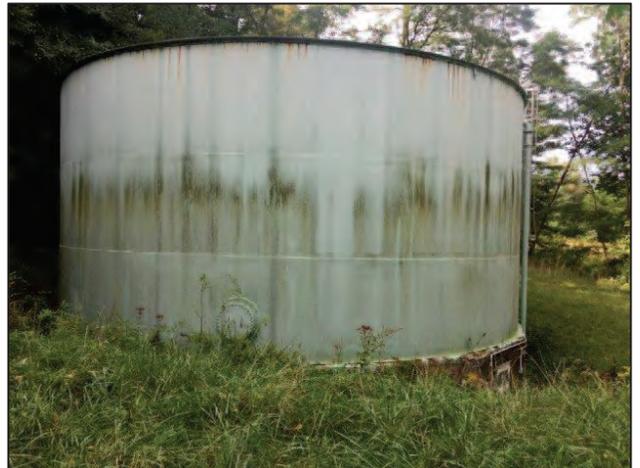
*Figure 2: Padua Tank*

1. This tank appears to be at the end of its useful life. The foundation appears to be crumbling and there is at least one bullet hole completely through the side wall. Mr. Pierce reports that he cannot completely fill the tank because of this hole. This tank must be rehabilitated or replaced. No information was available regarding recent inspection of the tank. AWWA Standard G-200 recommends internal inspections of all storage tanks be performed every 5 years.
2. The water main from the plant to this tank was installed in the 1930's. As this line is aging, and in an area that is not easily accessible, the Village should also consider replacing it.

1. Access to this tank is difficult. The Village should insure that there is an easement through the property and gravel pit. The road to the tank itself must be maintained to allow adequate access during all times of the year.
2. The Village should address security at the site. There is no fencing around the tank to restrict access.
