REPORT OF INVESTIGATION

Underground Nonmetal Mine
(Salt)

Fatal Falling Material Accident

Cayuga Mine
Cargill Deicing Technology
Lansing, Tompkins County, New York
Mine I.D. No. 30-00663

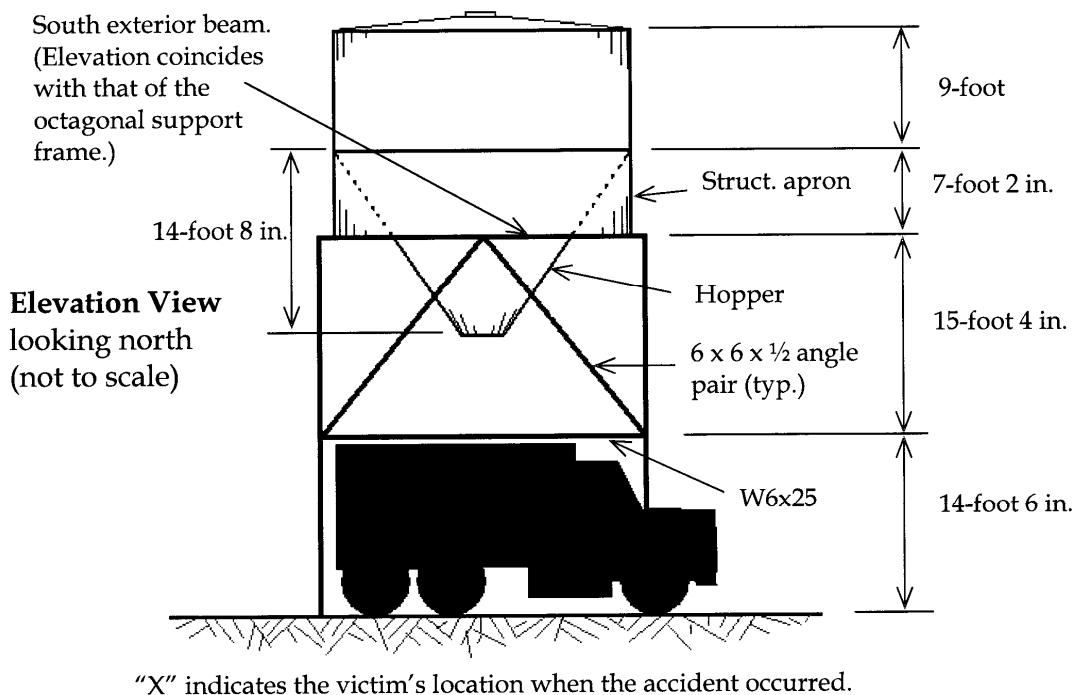
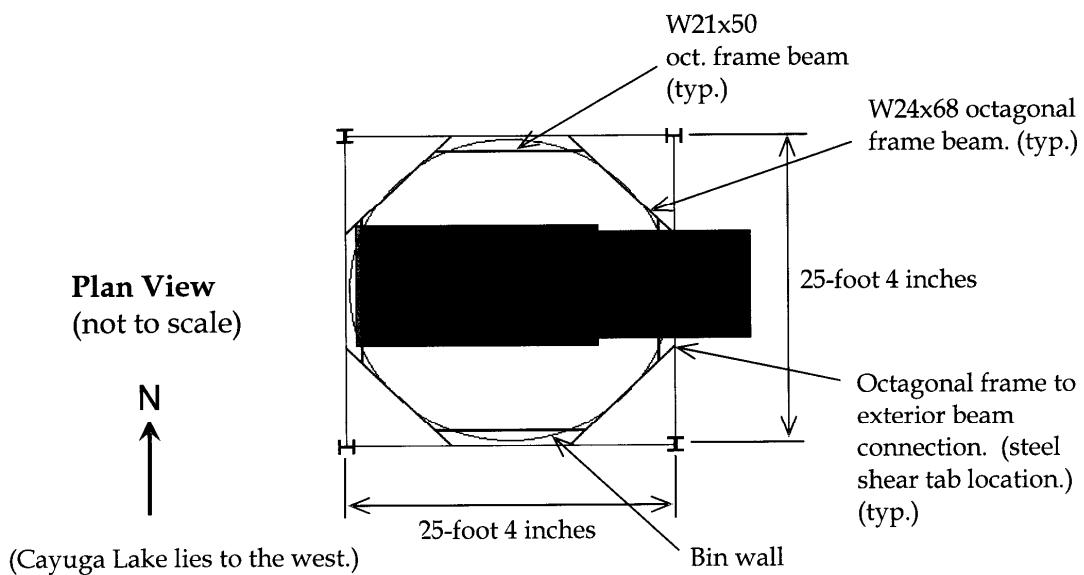
Schematic of Accident Scene

The bin structure involved in the accident was reportedly constructed in 1989. As shown in Appendix C, the bin and cone portion of the structure were supported by four 14-inch-deep (W14x99) steel columns positioned at each of the four corners of a 25-foot-4-inch by 25-foot-4-inch square frame. Each column extended vertically 29 feet 4 inches above its base, and was supported by a reinforced concrete foundation and anchor bolts. The columns were braced at mid-height by horizontal (W6x25) and diagonal (6 x 4 x ½ back-to-back angles) steel members. The square frame located at the tops of the columns consisted of 24-inch-deep (W24x68) perimeter beams. These perimeter beams were bolted to the support columns.

While relatively minor corrosion was observed at locations throughout the structure, severe corrosion damage was apparent in several of the shear tab connections between the octagon frame beams and the exterior perimeter beams. The shear tabs closest to the southeast support column were in the worst condition. Measurements were taken on all tabs to obtain the effective connective length and average thickness of each failed cross-section. The tab plate at the south end of the east exterior perimeter beam had only 10 percent of its initial cross-sectional area remaining. The shear tab connection at the east side of the south exterior perimeter beam had a similar degree of section loss. The bin weight, including its roof and accessories, was as 28,000 pounds as listed on the design drawings. By direct measurement, management determined the weight of salt in the bin at the time of the accident to be 233,000 pounds. Calculations of the stress on the shear tabs adjacent to the southeast column demonstrated that, at the time of the accident, they were loaded well beyond their capacity.

Failure of the tabs in the southeast corner of the structure led to a redistribution of the bin load, causing higher stresses on the remaining tabs. The redistribution of the load, as well as the introduction of dynamic effects, led to failure of less corroded tabs and the catastrophic collapse of the entire bin. This sequence was further supported by other observations made at the site. The west beam experienced significant torsional deformation during the bin collapse. The octagonal support frame exerted a large torsional force on the west beam as the bin moved and the shear tab connections were strong enough to deform the beam before failing. The scrape marks on the east face of the bin wall and the deformations of the roof on the east side of the bin indicated impact with the east-side exterior beam and possibly the beam in the lower east bay. This was consistent with a failure that initiated at the shear tabs nearest the southeast column. The cause of the collapse was the overloading of the severely corroded shear tab connections between the diagonal beams in the octagon framework and the main exterior perimeter beams adjacent to the southeast column.
